September 1945 as  
Memorandum Report E5I27a

**EFFECT OF MAXIMUM CRUISE-POWER OPERATION AT ULTRA-LEAN  
MIXTURE AND INCREASED SPARK ADVANCE ON THE MECHANICAL  
CONDITION OF CYLINDER COMPONENTS**

By Herbert B. Harris, Robert T. Duffy, and Robert D. Erwin, Jr.

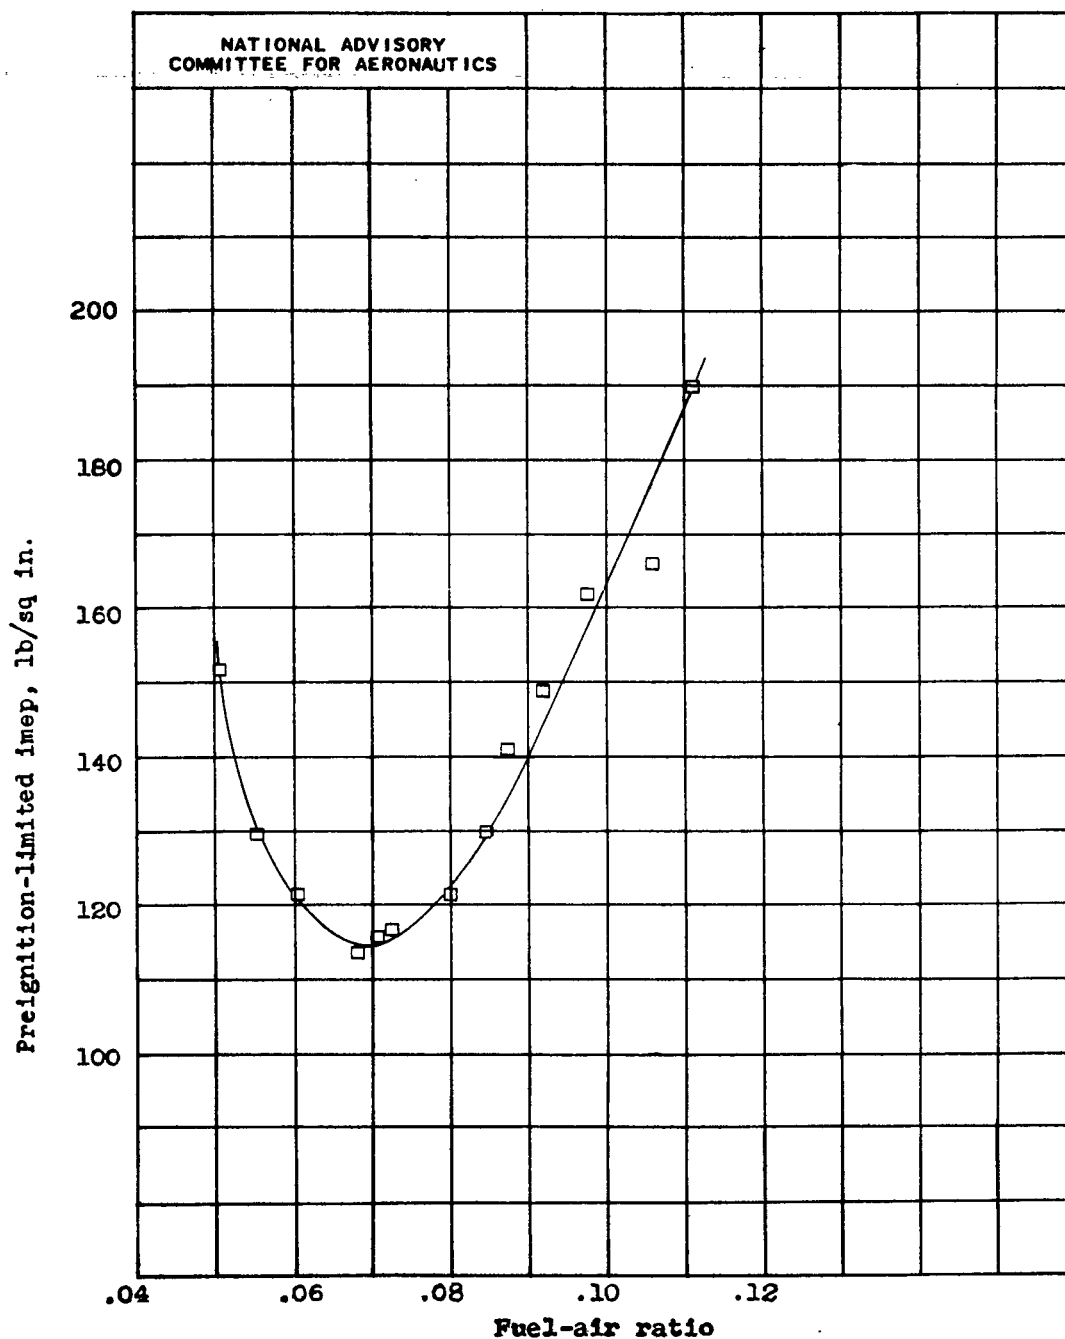
Figure 14. - Preignition-limited performance of 28-R fuel. CFR engine; open tube hot spot; engine speed, 1800 rpm; inlet-air temperature, 225° F; coolant temperature, 250° F; spark advance, 20° B.T.C.; compression ratio, 7.0. (Data from reference 15.)

Preignition. - Although preignition may be the result of engine knock, it may lead to engine failure without any indication of knock (reference 15). Figure 14 has been included to indicate the effect on the preignition-limited power output of engine operation at the conditions of this test as compared with operation at the conditions recommended by the Army for the same power. The data for this preignition-limit curve were obtained from a single-cylinder CFR test engine at an engine speed of 1800 rpm, at a spark advance of  $20^{\circ}\text{B.T.C.}$ , and at a compression ratio of 7.0 (reference 15). Because the engine and operating conditions for this curve are different from those of the test reported herein, a comparison of absolute values is not possible. The relative values, however, should be indicative of the effect of fuel-air ratio on the preignition limit of the engine used in this test.

The preignition-limited power for a fuel-air ratio of 0.052 is 21 percent higher than that for a fuel-air ratio of 0.076 for the same spark advance and engine speed (fig. 14). A correction of the preignition-limited power at a fuel-air ratio of 0.052 for the increase in spark advance from  $20^{\circ}$  to  $30^{\circ}\text{B.T.C.}$  made according to the data of reference 16 showed that it should be decreased approximately 20 percent. The effect of the 100 rpm difference in speed between the two conditions should be of comparatively small magnitude as indicated by the data of this reference. The net effect on the preignition-limited power output of engine operation at the conditions of this test as compared with operation at the conditions recommended by the Army for the same power should therefore be negligible.
